DEPARTMENT OF TRANSPORTATION

Office of Structural Materials

OBG CROSS BEAM CB1

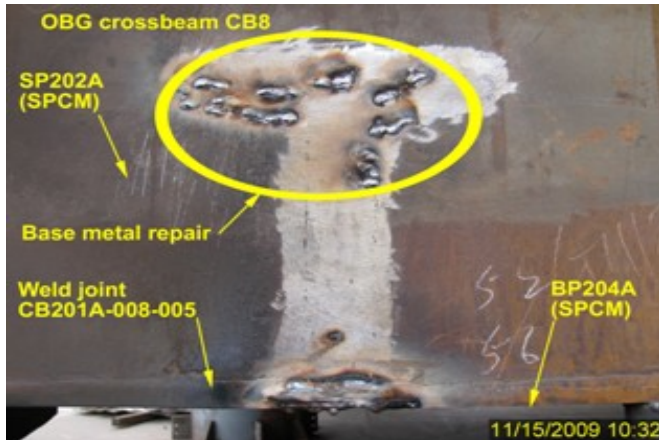
OBG CROSS BEAM CB8

This QA inspector observed ZPMC personnel appears to have performed base metal weld repairs on material designated as SPCM on the approved shop drawings without the Engineers approval. The areas being repaired were damaged while removing temporary lifting lug welds at the corners of this crossbeam. The component is identified as OBG crossbeam CB8. The SPCM panels affected are identified as side panel SP202A and bottom panel BP204A. AWS D1.5 2002 section 3.3.7.3 specifies “Tack welds not incorporated into the final weld shall be removed in such a manner that the base metal is not nicked or undercut. Repair of base metal accidentally removed shall be approved by the Engineer prior to making the repair. This QA informed ZPMC QA identified as Mr. Zhang Wei and ABF QA inspector identified as Mr. Kelvin Cheung of this issue and that an incident report would be generated. See attached photo.
